Protecting aquarium sea mammals and fish from pile driving noise and vibration

Marine mammals and fish on exhibit at the Maritime Aquarium in Norwalk, Connecticut were the subject of an extensive study to predict, assess, measure and control pile driving noise and vibration levels produced by construction activities associated with an upcoming major railroad bridge replacement project proximal to the aquarium. There was great concern that the aquarium's harbor seals, sea turtles and various fish species could be adversely affected or even harmed by stress from the pile driving. This paper will describe the development of relevant criteria limits, prediction of pile driver noise and vibration levels, and most importantly, the extensive measurements that were performed during a live pile driver test program conducted in late-2018. Air-borne noise, ground-borne vibration and hydro-acoustic levels were measured in real-time as test pile driving was conducted at nine locations using three different types of pile drivers. The results proved successful in protecting the aquarium's sensitive species of concern, and the resulting study reassured the Federal Railroad Administration (FRA), C

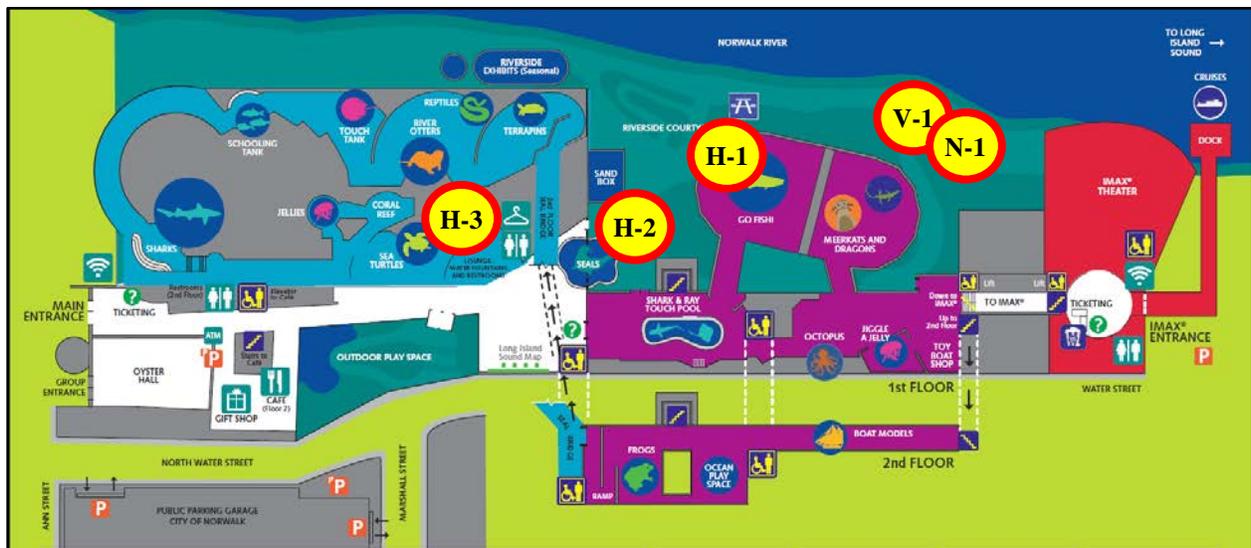
Figure 1: Aquarium noise, vibration, and hydro-acoustic monitoring locations

The criteria limits that were established in the Protocol are shown here in **Table 1**. **Figure 1** shows the aquarium noise, vibration, and hydro-acoustic monitoring locations during the TPP. Hydro-acoustic monitoring consisted of 1-minute samples in the Seal Tank to ensure that hydro-acoustic levels would not exceed 160 dB L_{max} ‘slow’ (representing potential disturbance) or 200 dB Peak (representing potential injury). Similarly, 1-minute hydro-acoustic samples were monitored in the Go Fish Tank to ensure hydro-acoustic levels did not exceed 150 dB Leq ‘slow’ (disturbance) or 206 dB Peak (injury). These hydro-acoustic criteria were adopted from ANSI/ASA S3/SC1.4 TR-2014 Sound Exposure Guidelines for Fishes and Sea Turtles⁽¹⁾, and guidelines from the National Oceanic and Atmospheric Administration (NOAA)⁽²⁾, the U.S. Fish and Wildlife Service (USFWS) and the National Marine Fisheries Service (NMFS)⁽³⁾.

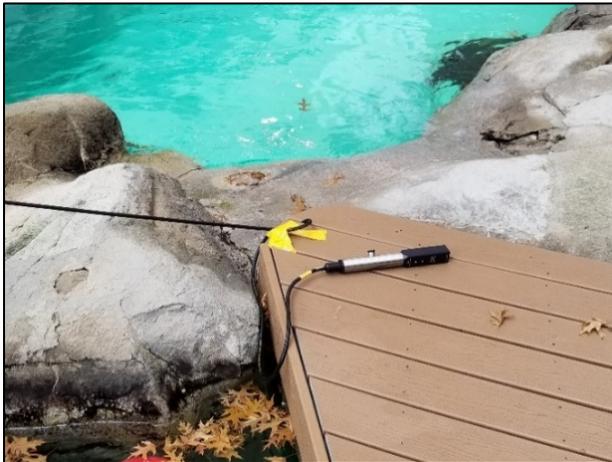
Photo 2: Hydrophone and calibrator in seal tank

Hydro-acoustic levels were measured using Reson Model TC4033 hydrophones, powered by Bruel & Kjaer Model 2635 charge amplifiers, streaming their data into a Sinus SoundBook for analysis and recording. The system was calibrated with a GRAS Model 42AC calibrator and BRC Model RA0078 hydrophone coupler. Pictures of the hydrophones in the Go Fish Tank and Seal Tank and the hydro-acoustic data collection system can be seen in **Photos 2 – 5**.

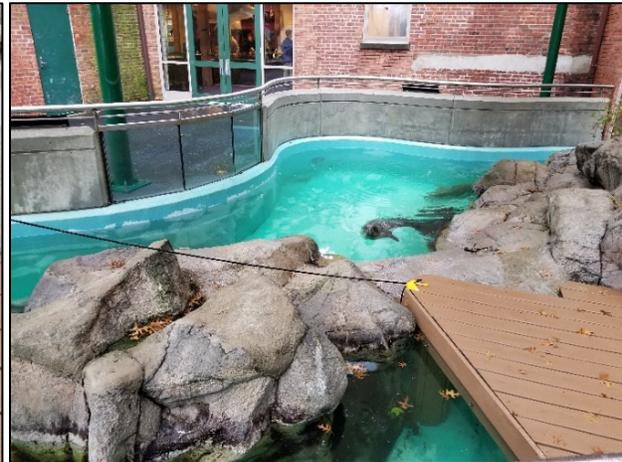
Photo 3: Hydrophone immersed in seal tank

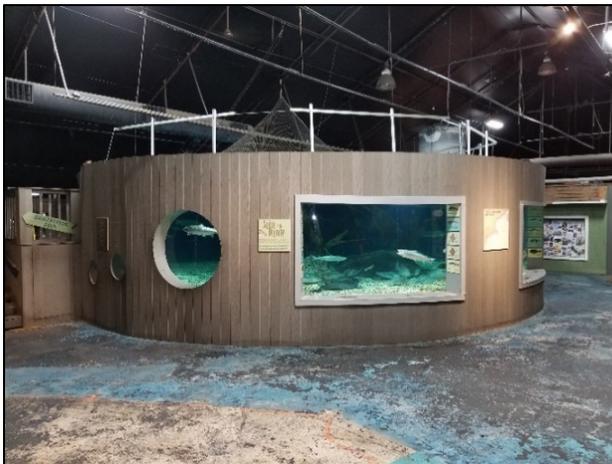
Photo 4: The go fish tank

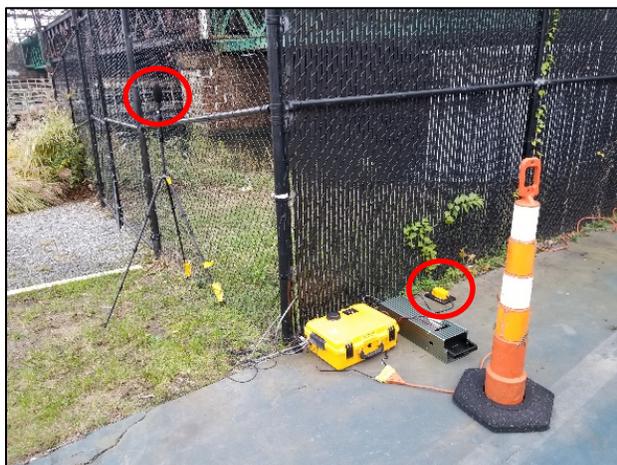
Photo 6: B&K EMS Sentinel automated monitors

Exterior noise and vibration levels were measured using a Bruel & Kjaer EMS Model 3655-C Noise Sentinel and a Model 3680-B Vibration Sentinel automated monitoring systems. The monitors were positioned behind the aquarium on pavement at the southeast corner of the property closest to the rail bridge. The Sentinels monitor noise and vibration levels on a continuous basis (24/7), upload the data to a host server in real-time, and send out automated alert messages in the event noise or vibration levels start to exceed specified thresholds. Pictures of the noise and vibration Sentinel systems can be seen in **Photos 6 – 7**.
